Manhole Inspection Summary

Manhole # S3500_025MH

Location Address: **350 23 1/2 ST**

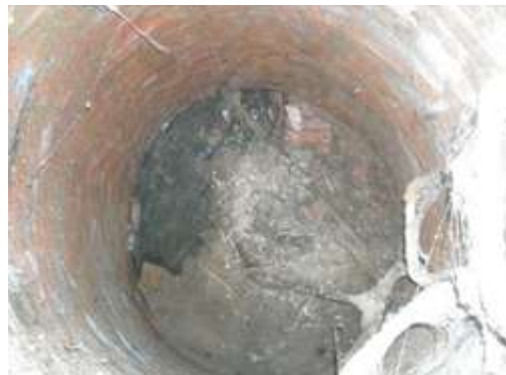
Top View

Evidence of surcharge - Bench debris.
Channel debris.

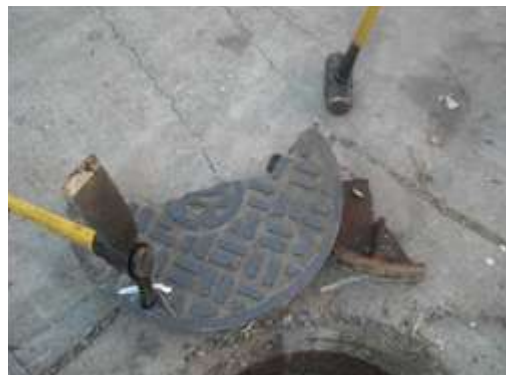
Broken lid

Broke the lid to gain access.

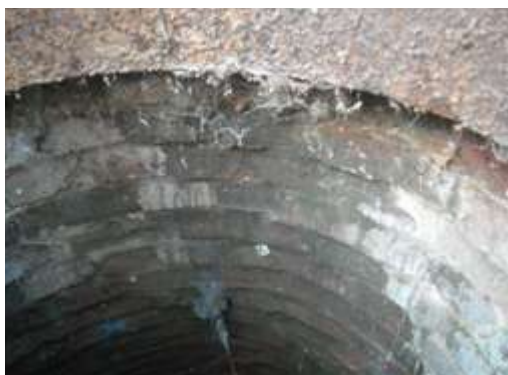
Defect

Adjustment deterioration and infiltration.
Corbel infiltration.

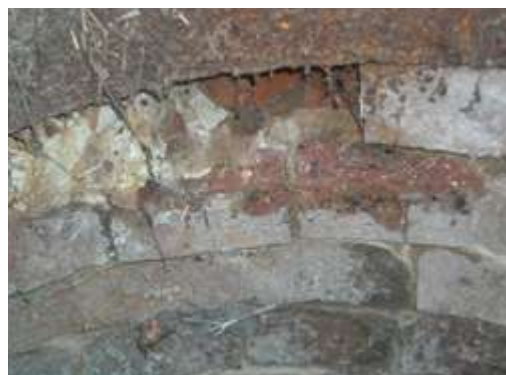
Defect

Adjustment deterioration and infiltration.

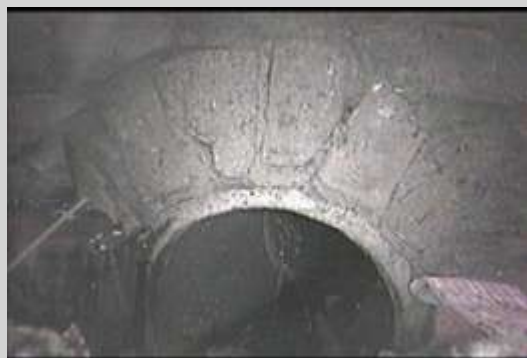
Pipe Out @ 12 O'Clock

Deposits: ☐ None ☒ **Mud** ☐ Sludge ☒ **Debris** ☐ Grease

Silt Depth: **1** (in.) Deposits Extent: **Light**

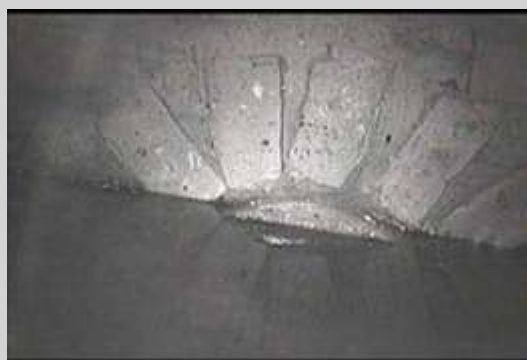
Pipe In @ 9 O'Clock

Deposits: ☐ None ☒ **Mud** ☐ Sludge ☒ **Debris** ☐ Grease

Silt Depth: **6** (in.) Deposits Extent: **Heavy**
